KILL THE PRESS: ISRAEL'S TARGETING OF PALESTINIAN JOURNALISTS

Case 1: The Assassination of Fatma Hassouna

14 May 2025

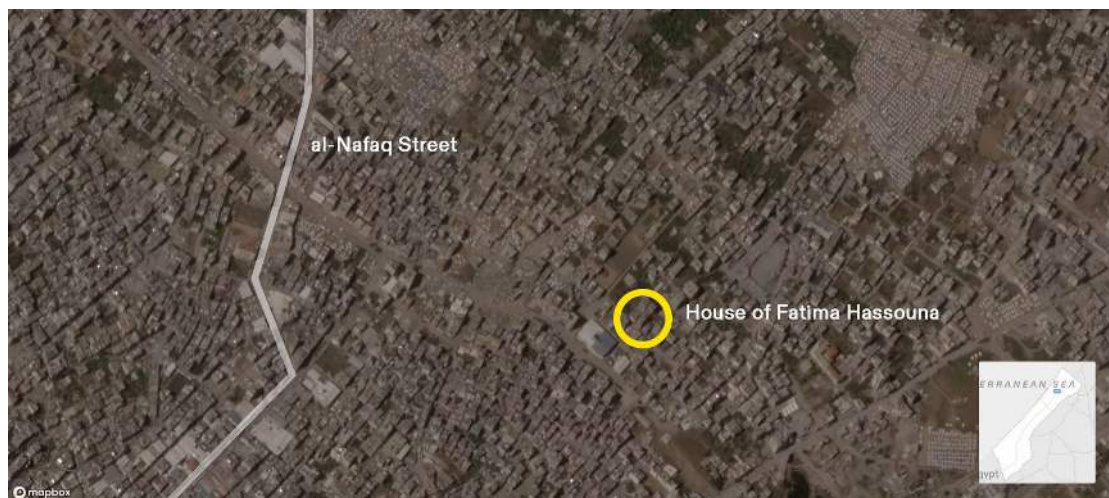
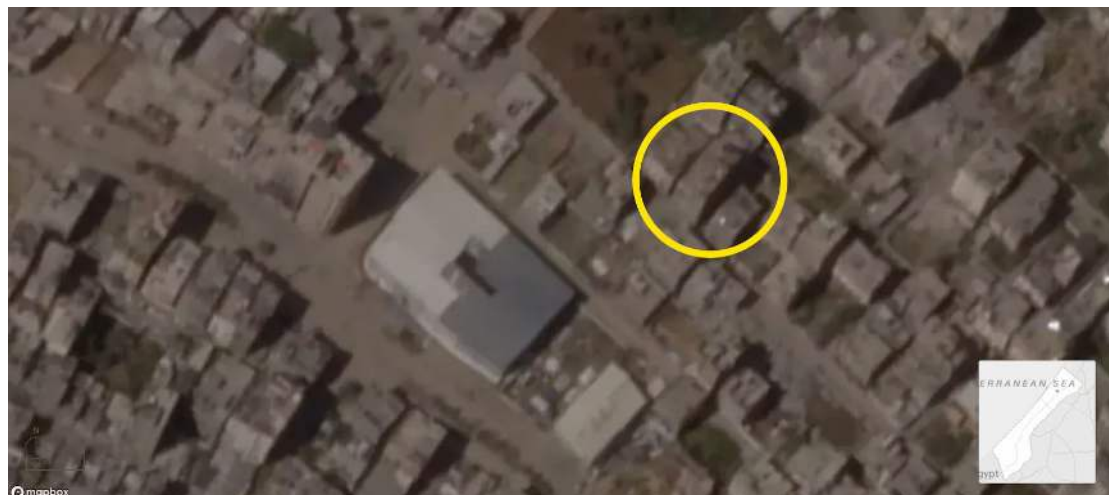
Satellite imagery from 15 April 2025 shows the building where the apartment was located standing largely intact and hence habitable. The building and its surrounding neighbourhood had not been under an evacuation order at this time.

Figure 1. Annotated satellite image showing the location of the Hassouna family home in Gaza City.

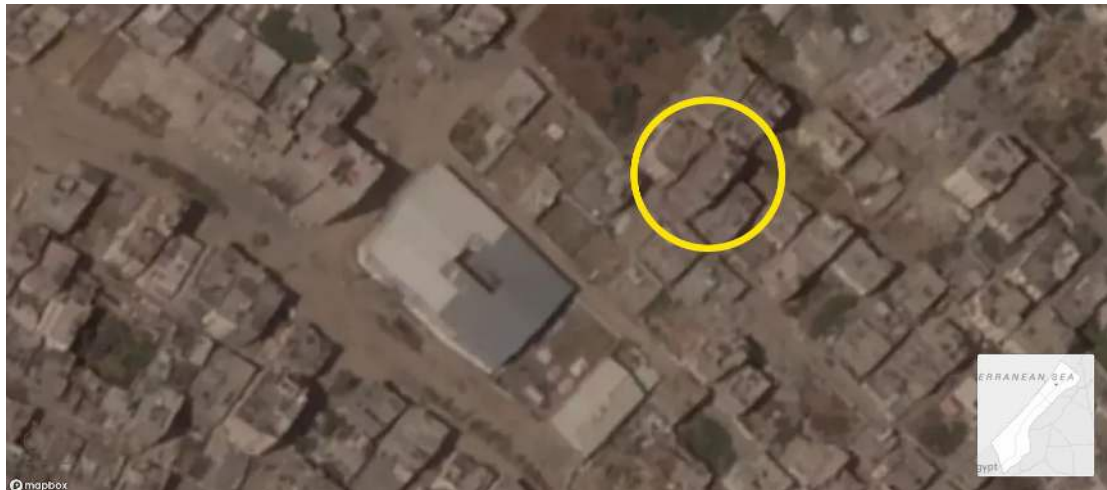
In satellite images from after the attack, the apartment building appears undamaged. This is because the munitions used in this strike (likely precision-guided munitions; see below) create very small holes upon impact.

The below satellite images have a resolution of 50cm – meaning each pixel represents 50cm. This means that any damage to the roof resulting in impact marks of 50cm or less in width would not be visible in the image.

Figure 2. Available satellite image from Planet Labs after the strike on 25 April shows the Hassouna family's apartment building at a pixel resolution of 50cm.

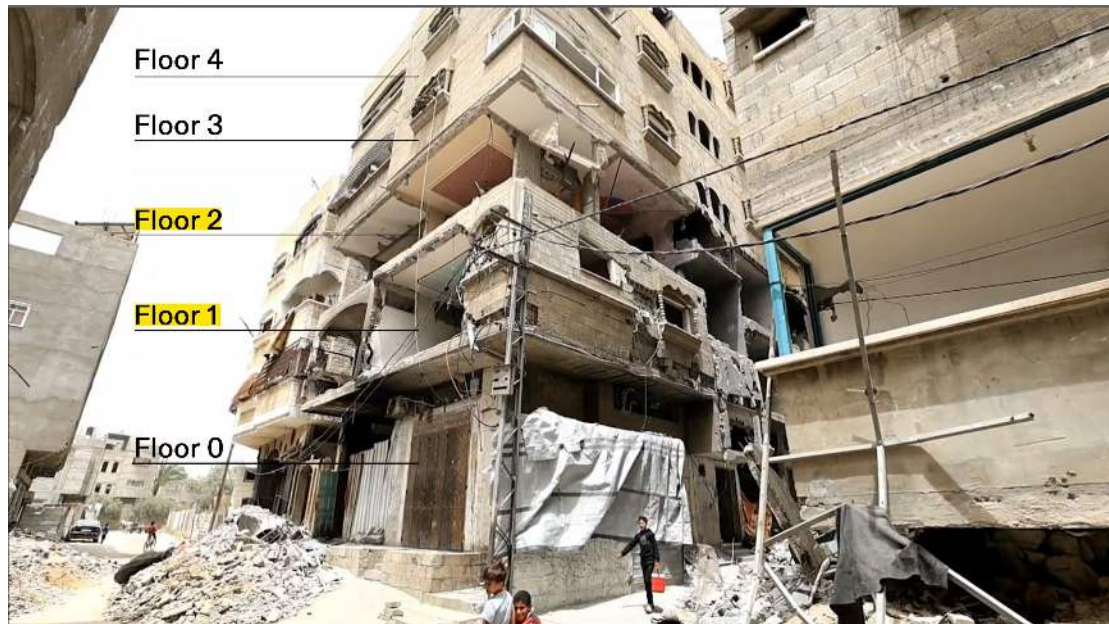
However, videos⁶ taken after the attack in early May from the street outside the building reveal that, while the upper floors as well as the ground floor remained largely intact, floors 1 and 2 of the building⁷ suffered extensive damage, with most of

their internal and external walls destroyed. The Hassouna family apartment was located on Floor 2.

Figure 3. Still from video shows damage to the internal and external walls of the building's first and second floors. The Hassouna family's apartment is on Floor 2 of the building. Video source: Monitor/WDR.

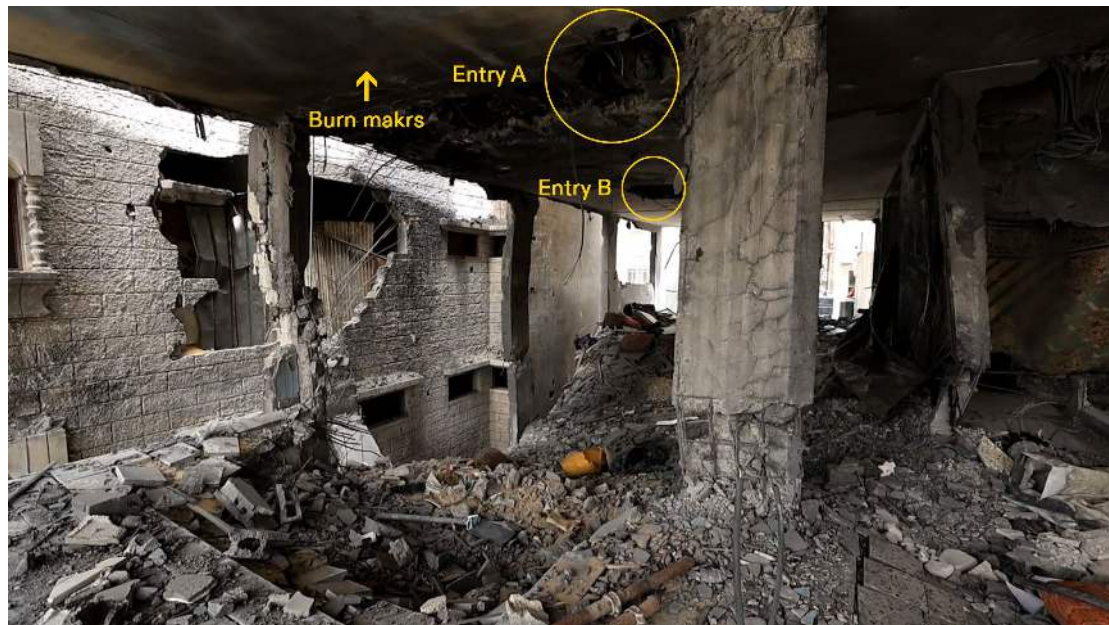
Videos documenting the inside of the apartment at this time show two entry points, where two munitions entered the apartment (Figure 4, Figure 5).

The entry holes are approximately 4m apart and the diameter of each is less than 50cm. Two points of entry close to one another suggest that the attack was targeted. The size of the entry holes is consistent with the signature of precision-guided munitions (PGMs) fired by Israeli jets or drones.⁸

The entry hole on the ceiling suggests a 'delay fuse' detonation, in which a munition penetrates layers of a building before detonating. A number of munitions known to be used by the Israeli military, including the AGM-114 Hellfire missile, can be fitted with a 'delay fuse', and are commonly used for targeted strikes.

Figure 4. Annotated still image from video documenting the apartment shows the location of the two entry holes. Video source: Monitor/WDR.

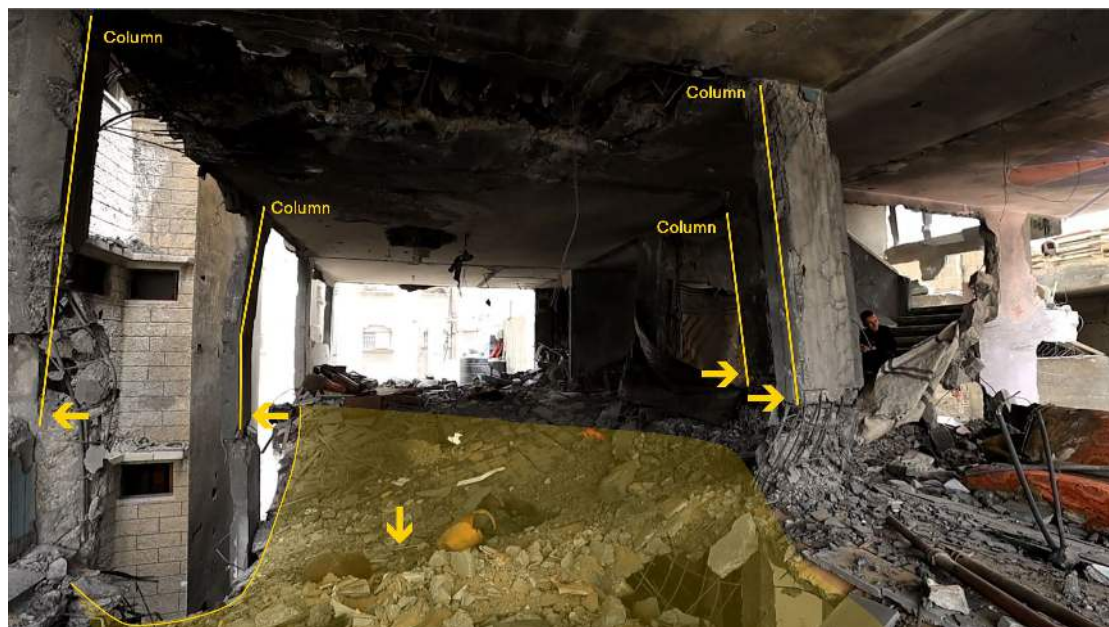
Such munitions cause intense fragmentation or localised burns which in this case is visible on the ceiling. One of the holes (Entry A) is near to a load-bearing column, causing greater destruction in that area.

Four of the load-bearing columns in the apartment, as well as the floor, show signs of being pushed 'outwards', likely the result of explosive force from inside the apartment.

Figure 5. Annotated still image from video documenting the apartment shows burn marks on the ceiling as well as the way the columns and the floor are pushed outward. Video source: Monitor/WDR.

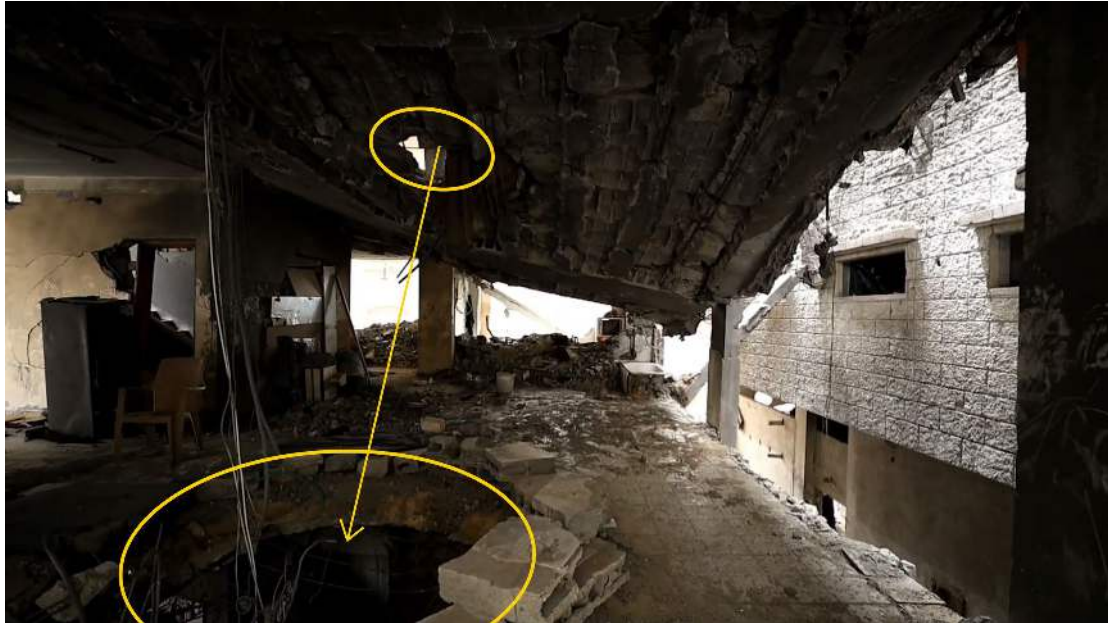
Additional images from inside the building (Figure 6, Figure 7) show a hole in the floor of the apartment, and a larger hole in the floor below (Floor 1), suggesting that one of the missiles passed through the Hassouna family's apartment, and the floor below, before detonating at ground level.

Figure 6. Annotated still image from video taken from Floor 1 showing the entry and downward exit of one of the missiles. Video source: Monitor/WDR.

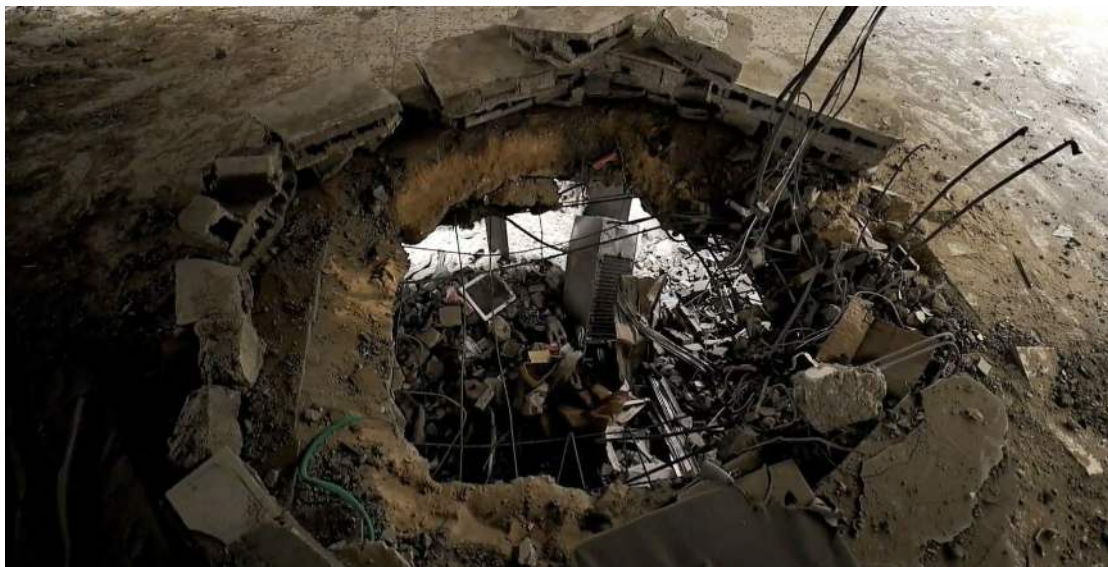
Figure 7. The hole from the 1st floor to the ground level of the building. Video source: Monitor/WDR.

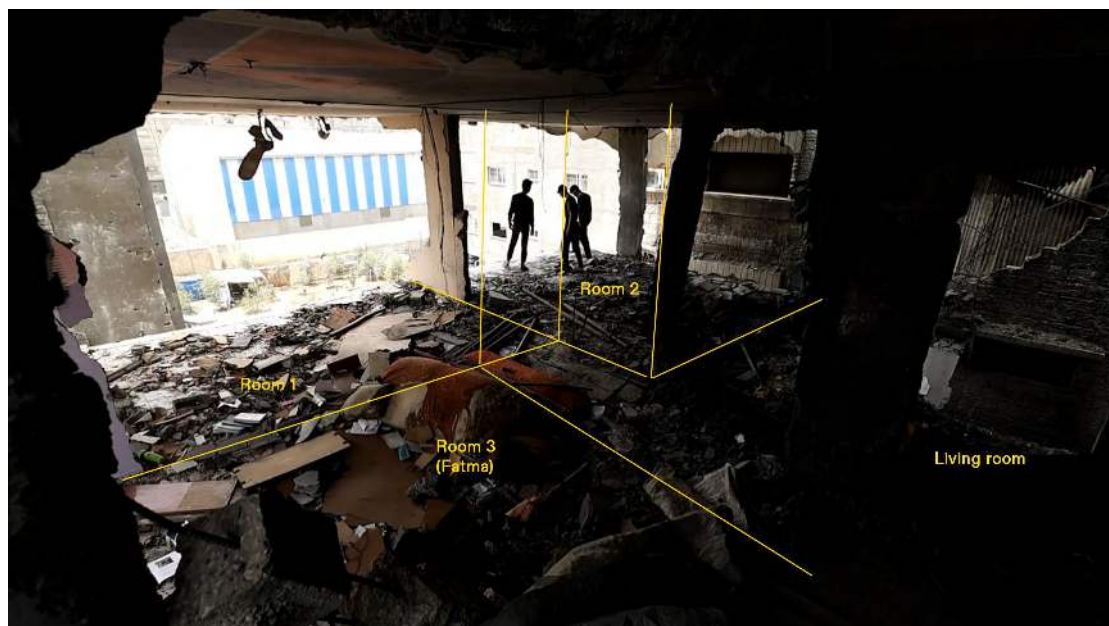
Videos also indicate that the explosion on Floor 2 caused extensive damage in other areas of the apartment, including to the room in which Fatma and other family members were sleeping at the time.

Figure 10. Architectural analysis (above) drawn from videos taken after the incident confirm extensive damage to all areas of the apartment. Annotated still image (below) from video documenting the apartment shows the rooms impacted. Video source: Monitor/WDR.
